**UNIVERSITY INSTITUTE OF AUTOMOTIVE RESEARCH**

**REPORT ABOUT  
TRIALS MADE ON  
VIGIA EQUIPMENT**

Ref: **10IA1747**

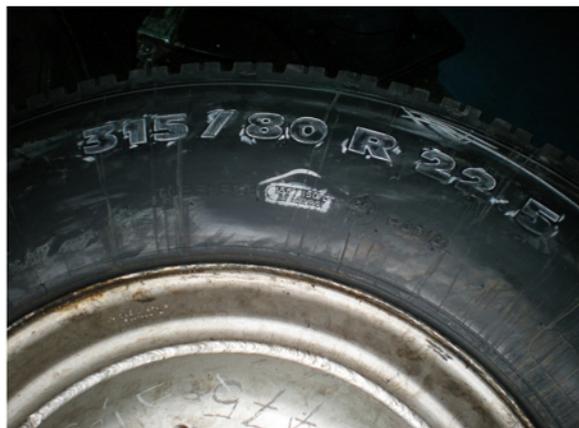
- . Brand: Michelin
- . Model: XDA 2+ Energy
- . Size: 315/80 R22.5
- . Manufacturing date: 0710

Both tires are new with 0 Km. Both are assembled in INSIA, with equipment and rims from this laboratory. The assembly is detailed in the following section.

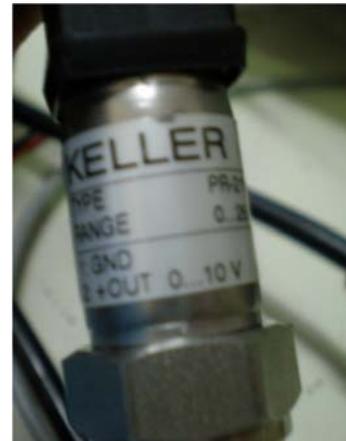
Besides, the pressure will be controlled analogically with the VIGIA equipment and digitally with two sensors of pressure supplied with 24 V and a KELLER brand 0-25 bar scale, model PR-21.

These sensors will be installed in the control room of the trial and as close as possible from the VIGIA equipment in order to have the best and precise measure about the functioning of the system and with no delays.

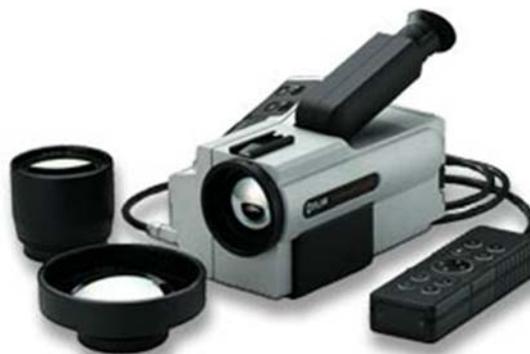
For this, a thermographic camera, model Thermacam 2000 of FLIR systems has been used property of INSIA. This camera was calibrated to measure the temperature on rubber with an emissivity coefficient  $c_e=1$

This camera was installed on a metallic cage inside the tire cell; in order to avoid possible strokes due to unexpected tire failures. The complete cabling was taken to the testing control area.

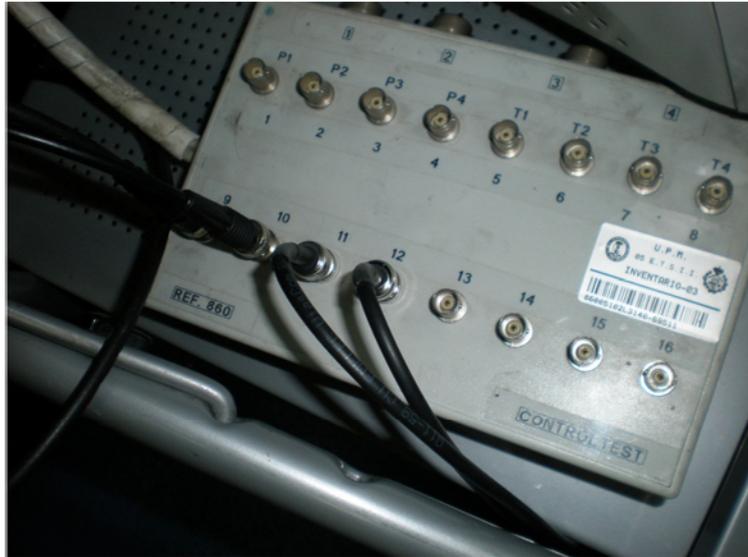
To make the wiring for the signals coming from the pressure and strength sensors applied to the tire, a connection box is used through BNC's that INSIA has and which is correctly tested.

Channels 9 and 10 will be used to get the pressures from 1 and 4 respectively and channels 11 and 12 to get the strength 1 and 4 applied to the tires.

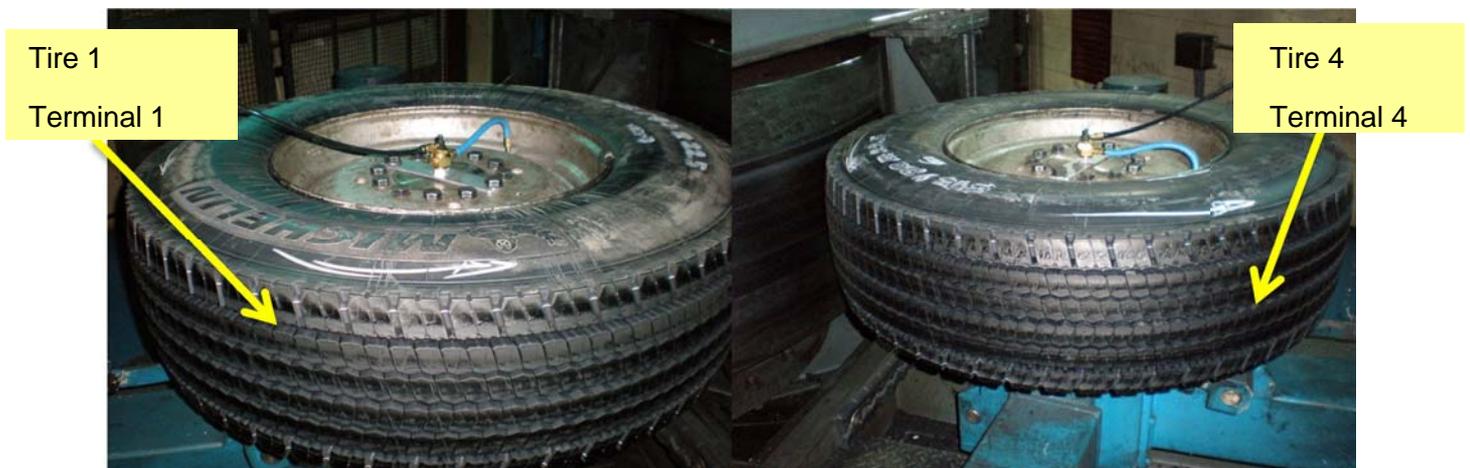
Then, we locate them in terminals 1 and 4 of the testing machine as shown below:

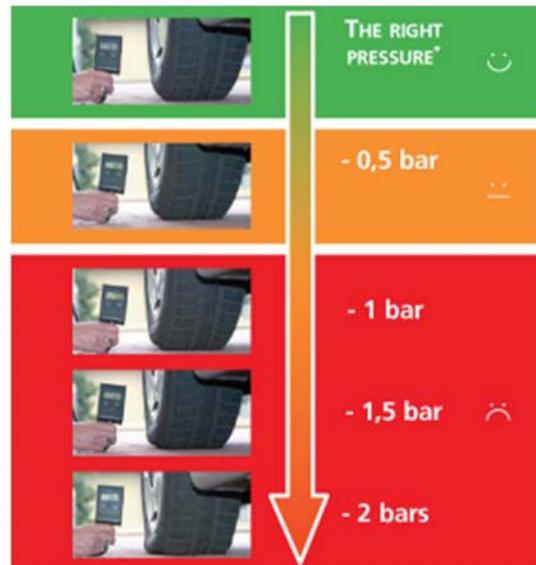
The correct pressure reduces the risk to loose control of the vehicle. It also protects the tires from a premature wear and irreversible internal damages. Tire pressure may also decrease due to small holes, because of the natural escaping of air though the tire components or even due to the low ambient temperature. The tire pressure must be checked every month and before travelling, including the spare tire, preferably with the tires cold (less than 4 kilometers of rolling at low speed). If the pressure is checked in warm, it is recommended to add 0.3 bar of pressure. It is very important to check the pressure once a month because:

- Low pressure increases the risk of damaging the tires
- An overpressure of 20 % reduces the lifetime of the tire
- A correct pressure increases the lifetime of the tire and it saves overfuelling
